**UNITED STATES DISTRICT COURT
NORTHERN DISTRICT OF CALIFORNIA**

CHART INC.

Case No. 3:20-cv-04991

**COMPLAINT AND
DEMAND FOR JURY TRIAL**

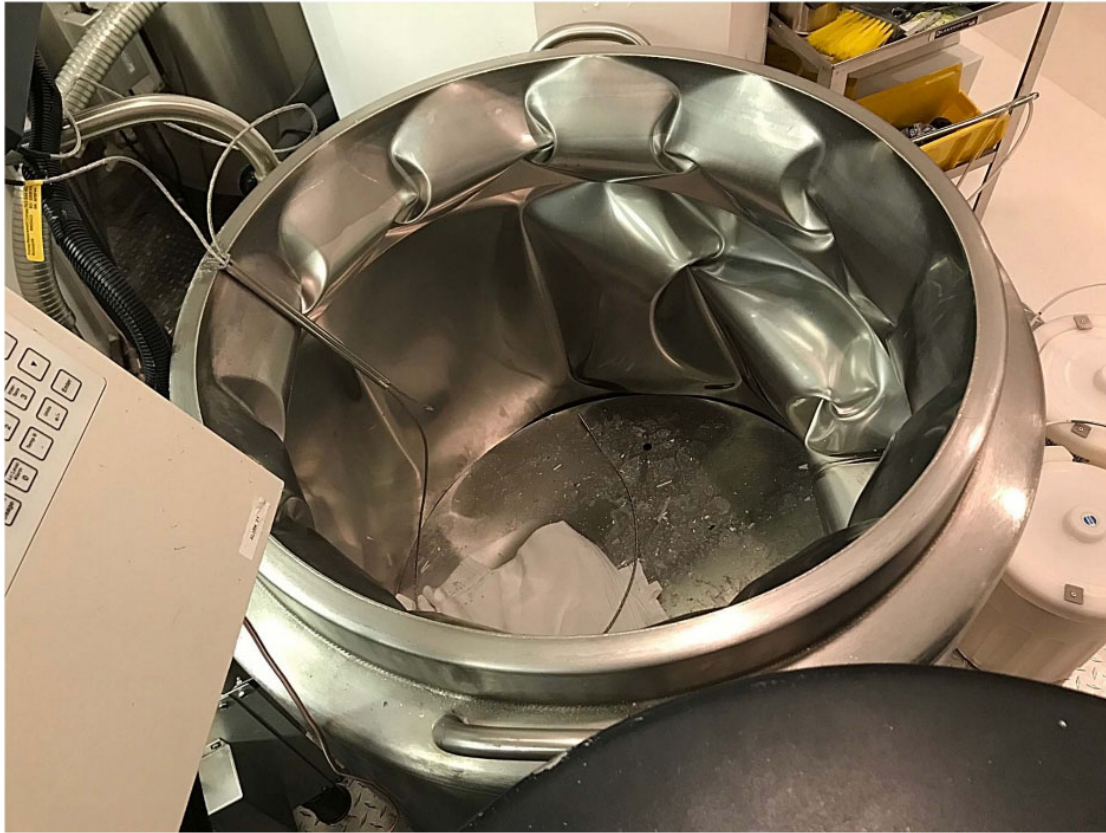
32. When the faulty weld cracked, the vacuum space was no longer separated from the inner vessel where PFC kept its patients' eggs and embryos. Liquid nitrogen was sucked into the vacuum space, where it expanded into nitrogen gas and pressurized the space between the inner vessel and outer vessel.

33. The crack and accompanying leak of liquid nitrogen into the interstitial space both destroyed the vacuum insulation that allowed the inner vessel to stay cold and exerted significant pressure on the space between the tank's inner and outer vessel. The inner vessel gave way and crumpled. The following image was taken approximately 36 hours after the PFC embryologists discovered the Tank 4 failure and moved the affected eggs and embryos to another tank.

Tank 4 after the incident
